REPORT : MEASUREMENT AIR FLOW

MEASUREMENT AIR FLOW P.ST. Panel Plus by GREAT ORIENTAL TRADING CO.,LTD

Tuesday, Aug 25, 2020

SERVICE REPORT

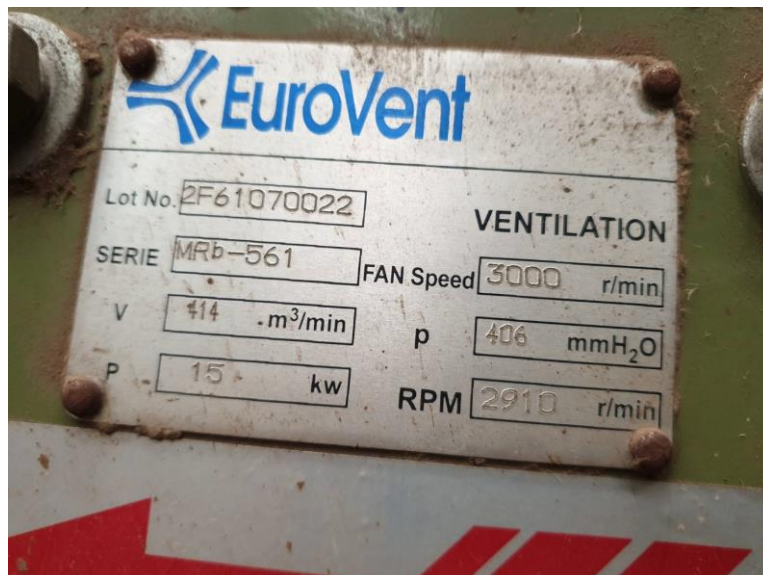
BLOWER SPECIFICATION

"EUROVENT" BLOWER

Lot No: 2F61070022

Serie: MRb-561

Fan: Speed 3000 r/min

V: 414 m³/min

p: 400 mmH₂o

P: 15 kW

RPM: 2910 r/min

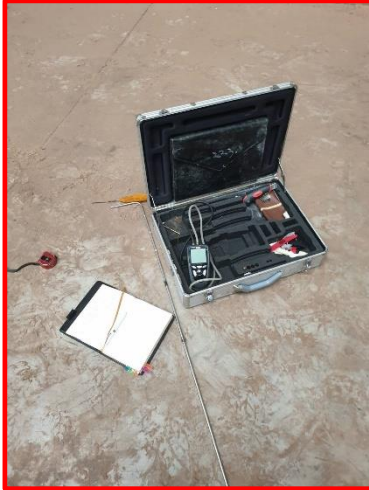
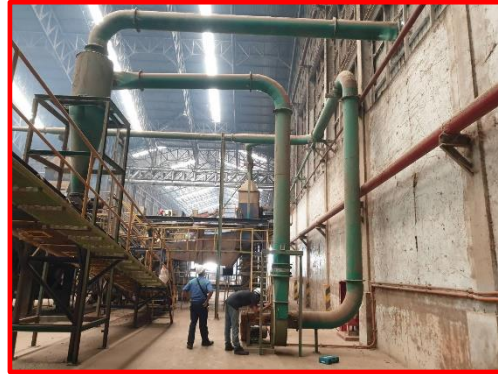
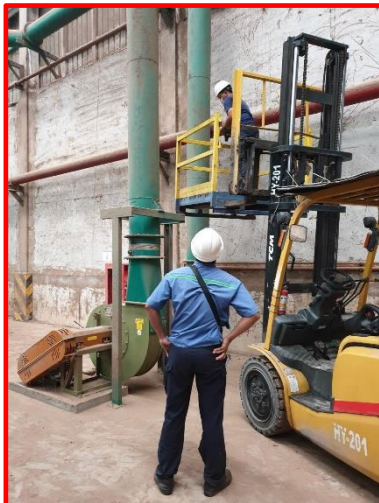
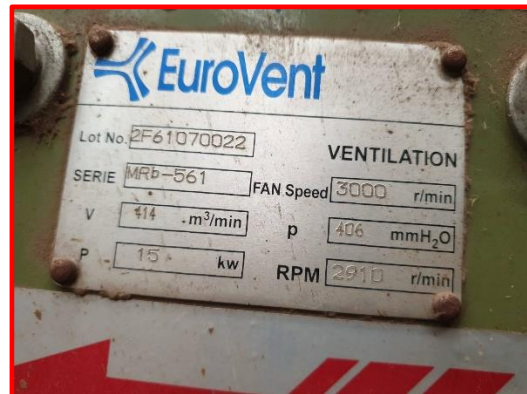
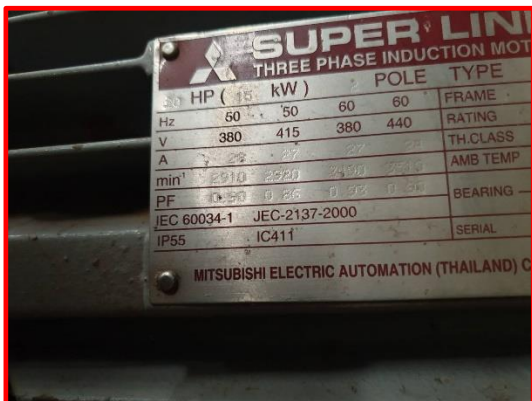
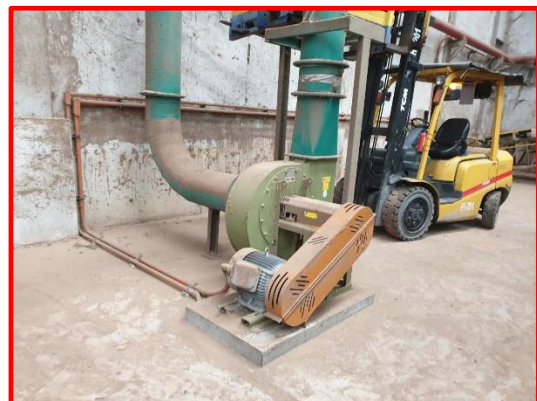
BLOWER PICTURE

Problem : • Blower ดูดฝุ่น Airlock มีฝุ่นหลุดออกมา

Service Report : • เข้าวัดลมทางเข้าและทางออก Blower

Range Left	Range Center	Range Right
Flow(m ³ /h)	5579	4682	5105
Veloc(m/s)	15.2	12.8	13.9
P+(mmH ₂ o)	316	316	315
P-(mmH ₂ o)	-303	-306	-305

Range Left	Range Center	Range Right
Flow(m ³ /h)	5663	5373	4519
Veloc(m/s)	15	14.3	12.3
P+(mmH ₂ o)	-112	-111	-108
P-(mmH ₂ o)	127	126	124
